#PIP5029B: Engine Misfires Due To Major Carbon Deposits On The Intake And Or Exhaust Valves - (Sep 24, 2012)

Subject: Engine Misfires Due To Major Carbon Deposits On The Intake And Or Exhaust Valves

With any of the Following Direct Injected Gasoline Engines:

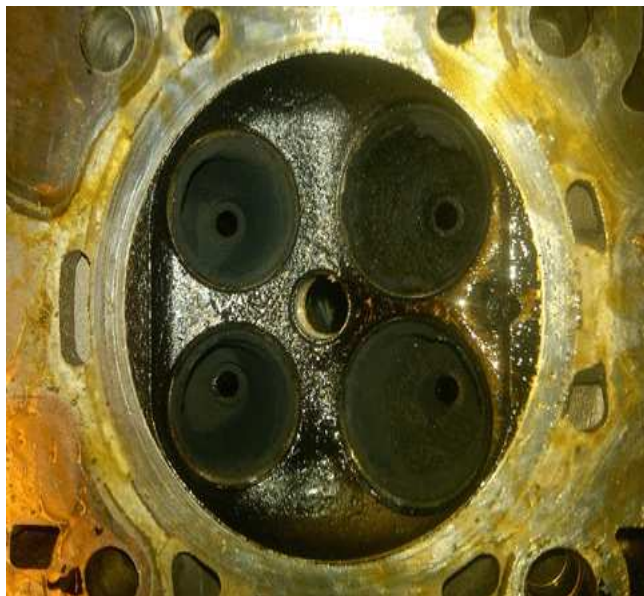
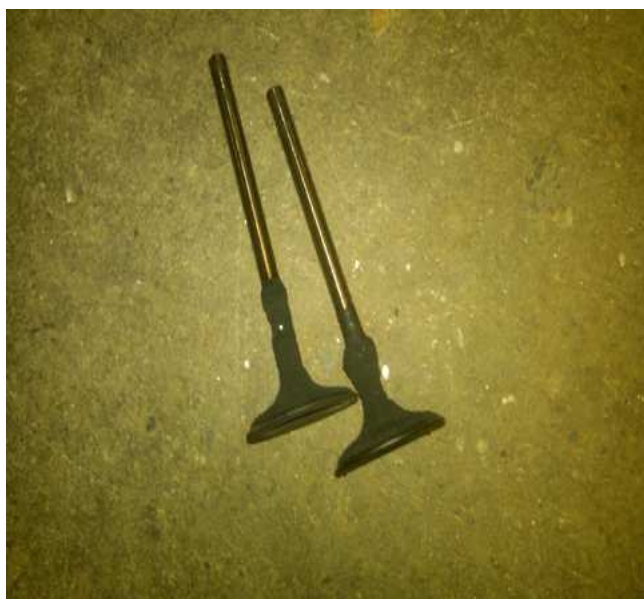
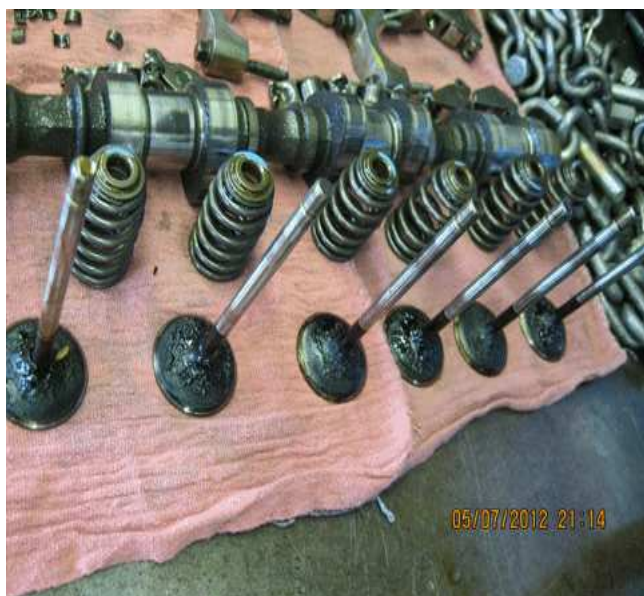
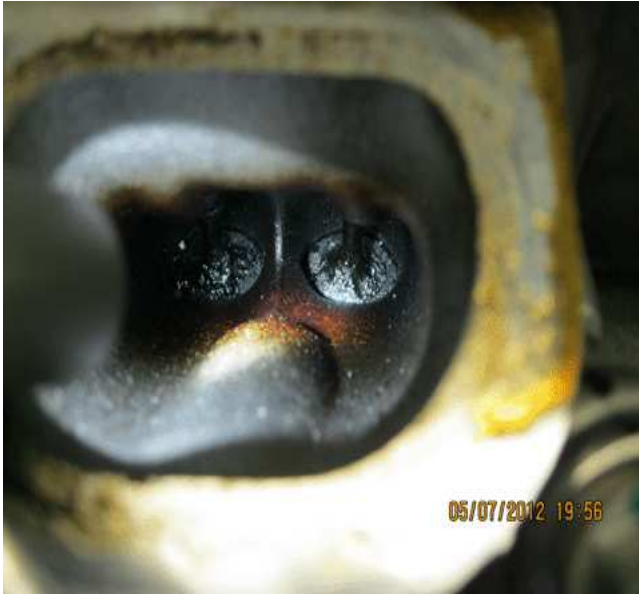
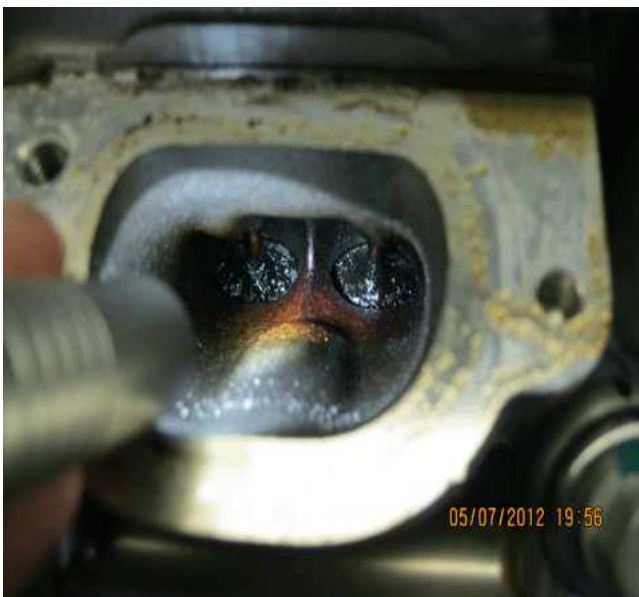
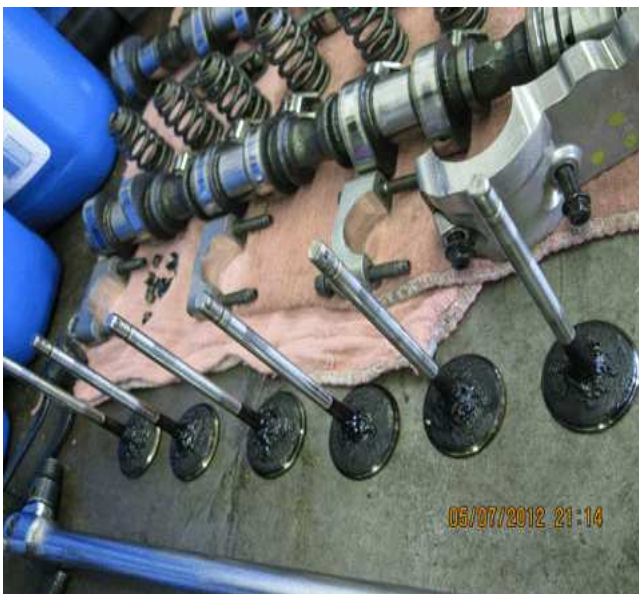
Some customers may complain of a MIL and engine misfire. In some cases, the misfire may be more apparent on a cold start, may count on a single cylinder or several cylinders, and may or may not be felt by the driver. Upon inspection, the technician will find one or more misfire codes (DTC P0300-P0306) stored in the ECM and SI diagnosis may or may not isolate the cause of the misfire depending on whether the intake/exhaust valves are sticking at the time of the diagnosis.

This may be the result of major carbon build up on the intake and/or exhaust valves as shown below so the misfires should not have appeared until at least 5,000 miles or more.

If this concern is encountered, perform SI diagnosis. If SI diagnosis isolates a valve sealing concern and/or eliminates everything else external to the engine, decarbon the engine with Upper Engine and Fuel Injector Cleaner by following the guidelines below:

Important: Extreme care must be taken not to hydro lock the engine when inducing the cleaner, especially if it is induced without Kent Moore Tool # J-45076 / J-35800-A or equivalent. If too much cleaner is induced at too low of a RPM, or if you force the engine to stall by inducing too much cleaner at once, the engine may hydro lock and bend a connecting rod(s).

1. In a well-ventilated area with the engine at operating temperature, slowly/carefully induce a bottle of GM Upper Engine and Fuel Injection Cleaner into the engine with RPM off of idle enough to prevent the engine from stalling (typically around 2,000 RPM or so). Depending on the engine configuration, induce the cleaner through the throttle body or an engine vacuum hose/pipe. For best results, it is suggested to induce the cleaner through the throttle body with Kent Moore Tool # J-45076 / J-35800-A or equivalent (shown below).

2. Turn the engine off after inducing the cleaner and allow the cleaner to soak with the engine off for 2.5 to 3 hours (Do not let cleaner soak for more than 3 hours as remaining deposits may start to harden back up again).

3. Add a bottle of GM Fuel System Treatment Plus to the fuel tank and fill the vehicle with one of the Top Tier gasolines listed at <http://www.toptiergas.com> and/or in the latest version of 04-06-04-047 (USA) or 05-06-04-022 (Canada). See Bulletin 05-00-89-078 for more details on GM Fuel System Treatment Plus.

4. Test drive the vehicle extensively to circulate the GM Fuel System Treatment Plus.
5. Re-evaluate the concern to determine if it is repaired or improved at all. If the concern is improved but not repaired, it may be necessary to perform the above decarboning process a 2nd time.

6. To complete the repairs, advise the customer to only use one of the Top Tier Gasolines listed at <http://www.toptiergas.com> and/or in the latest version of 04-06-04-047 (USA) or 05-06-04-022 (Canada) to minimize future deposits. It can also be recommended to add a bottle of GM Fuel System Treatment Plus at every oil change as mentioned in the latest version of 04-06-04-051.

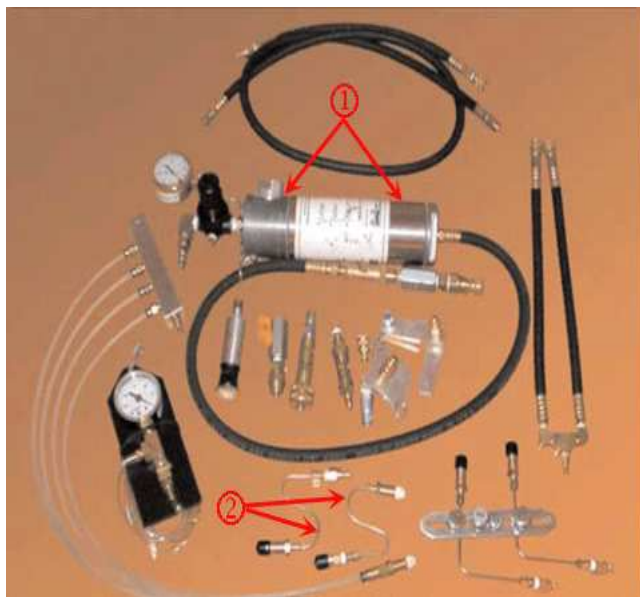
Kent Moore Tool Kit # J-45076

1. Pressurized Canister from J-45076 is shown - J-35800-A is similar
2. Throttle Body Cleaning Adapters J-45076-46 and J-45076-55 Shown (Equivalent Adapters Acceptable)
