## 2003 Audi A4 testing

An Audi A4 equipped with a 1.8L AMB turbocharged engine was in for service. The owner had just received it back from his kid, indicating it was neglected, having few if any oil changes performed. The services requested were an oil change, checking the air bag system, and advising on the check engine lamp.

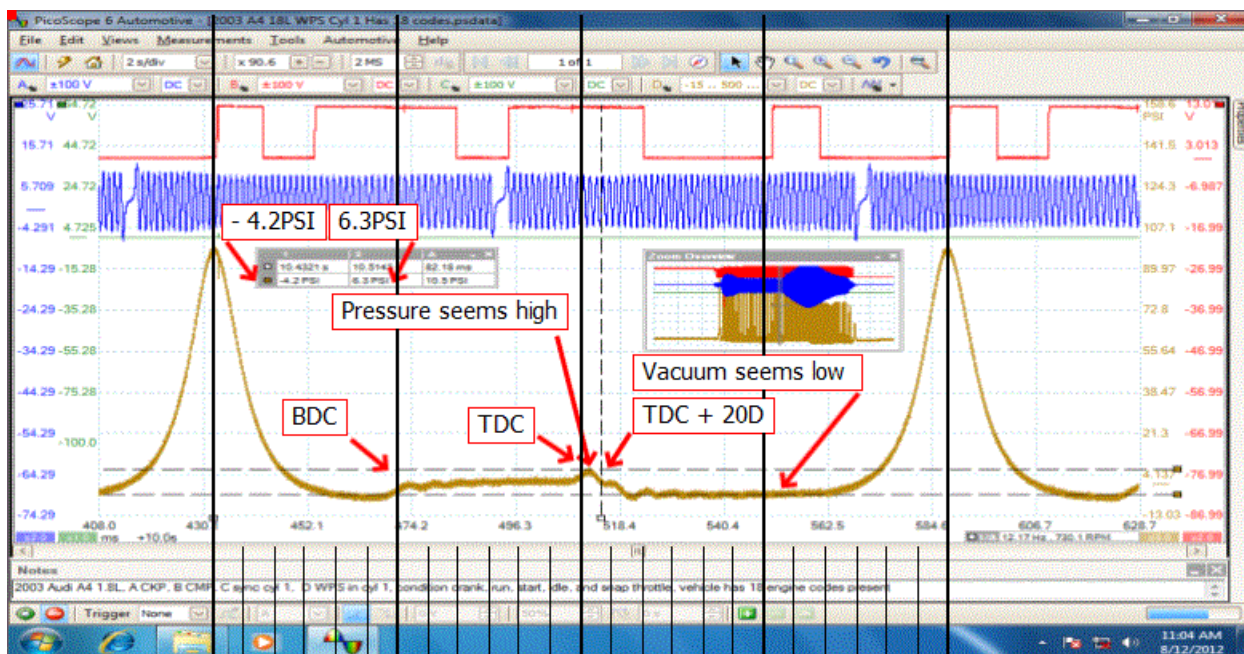
### Pressure transducer cylinder 1

A lot more than cam timing is displayed in the waveform, in this case I saw two potential faults. The pressure rise before the intake seemed high. Also, the vacuum during the intake portion seemed low. In the Denver metro area, a good vacuum reading is in the 15 to 17"HG range, with an actual barometric pressure usually in the 24 to 25 "HG range. A traditional vacuum gauge was connected to the intake manifold. A reading of 8"HG was recorded. In addition the back pressure of the exhaust was tested with the upstream exhaust sensor removed. A peak reading between 14 and 18PSI was recorded. At this point I was not certain if back pressure testing on a turbo equipped vehicle was different than a traditional naturally aspirated engine. At this point, I posted a question on it in international technician network (IATN) in the technical theory forum. Below are images of testing.

The test was to place a pressure transducer in cylinder one then crank, start, idle and then perform a snap throttle. Four channels are displayed yellow is the pressure sensor, red is the camshaft position sensor, blue is the crankshaft position sensor and green is an ignition sync to cylinder one. The waveform presented is at idle. In this image the BDC marker is typical of good exhaust camshaft timing. The TDC plus 20 is questionable, indicating a possible fault with the intake camshaft timing. The sync for cylinder one is not very clear, but it appears ignition spark is taking place after the compression event. This may also indicate a fault most gasoline engines have spark occur before the compression peak.

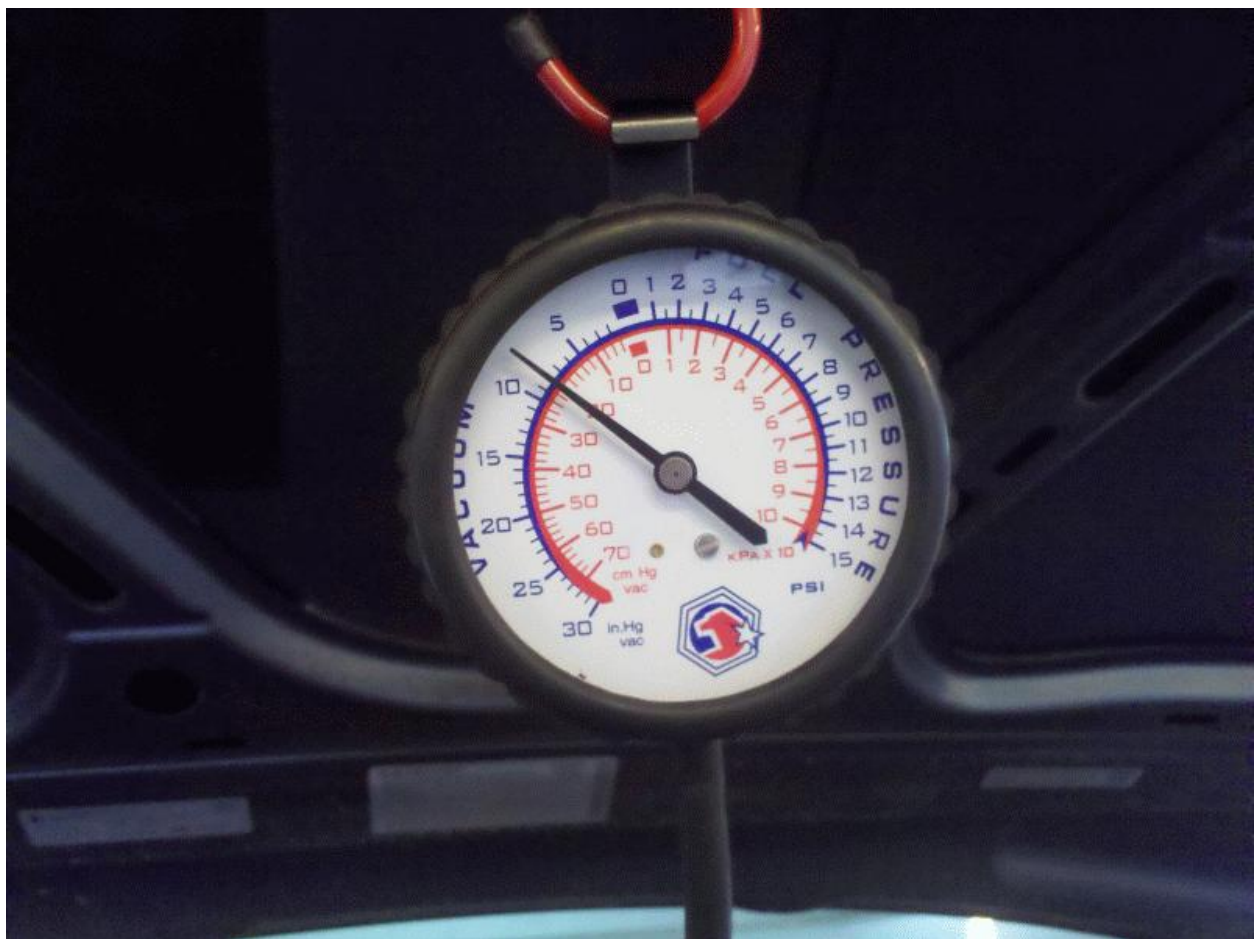
Vacuum gauge in intake

A vacuum gauge was tied in, using a tee at the front on the intake manifold. A good reading at sea level is 20'HG. Vacuum decreases as the altitude increases. A good reading at the elevation tested is 15 to 17"HG. The value recorded is definitely low.

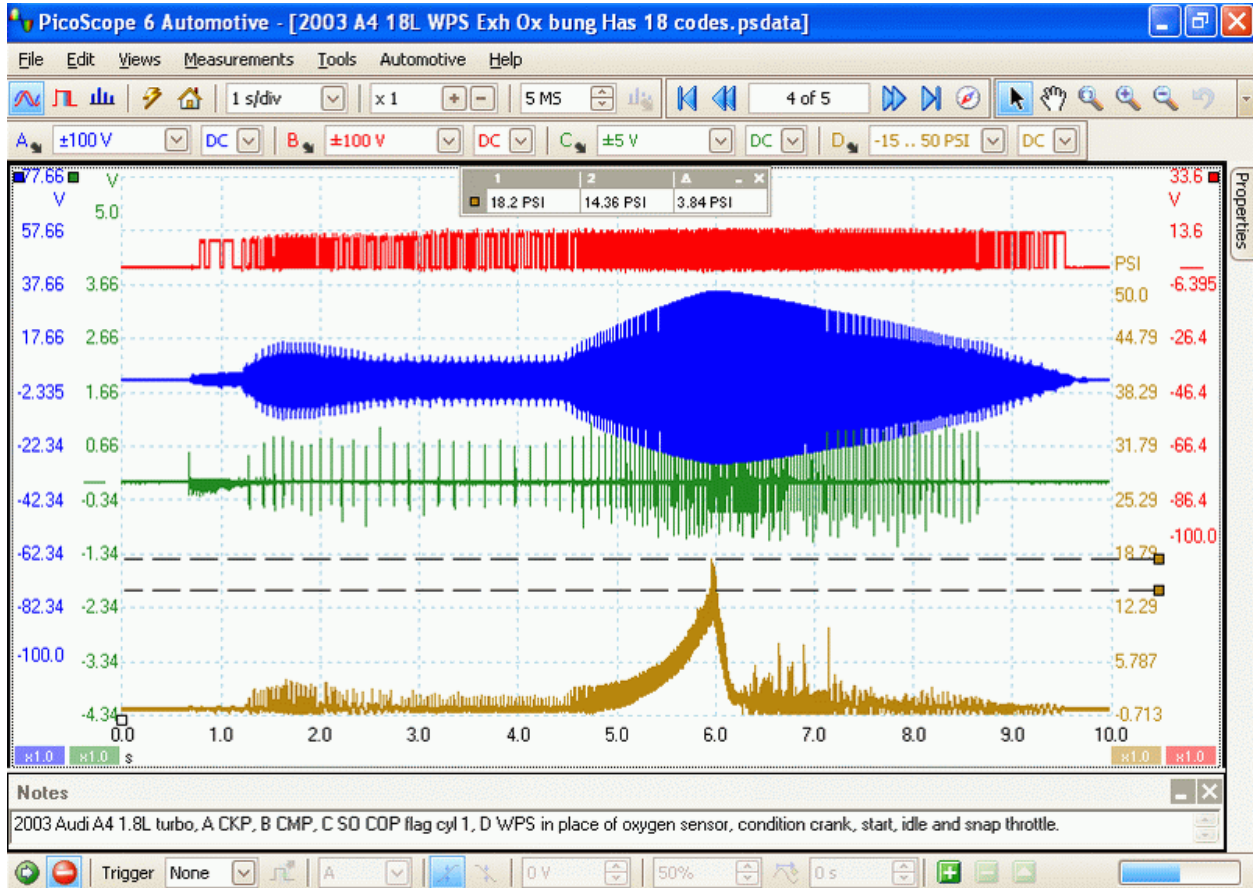
## Back pressure

This test was again crank, start, idle then snap throttle. The connection for blue, red and green remained the same capturing crank / cam sensor and cylinder one ignition. Yellow, is now the pressure transducer connected into the exhaust in place of the upstream exhaust sensor. This allows direct pressure testing of exhaust system.

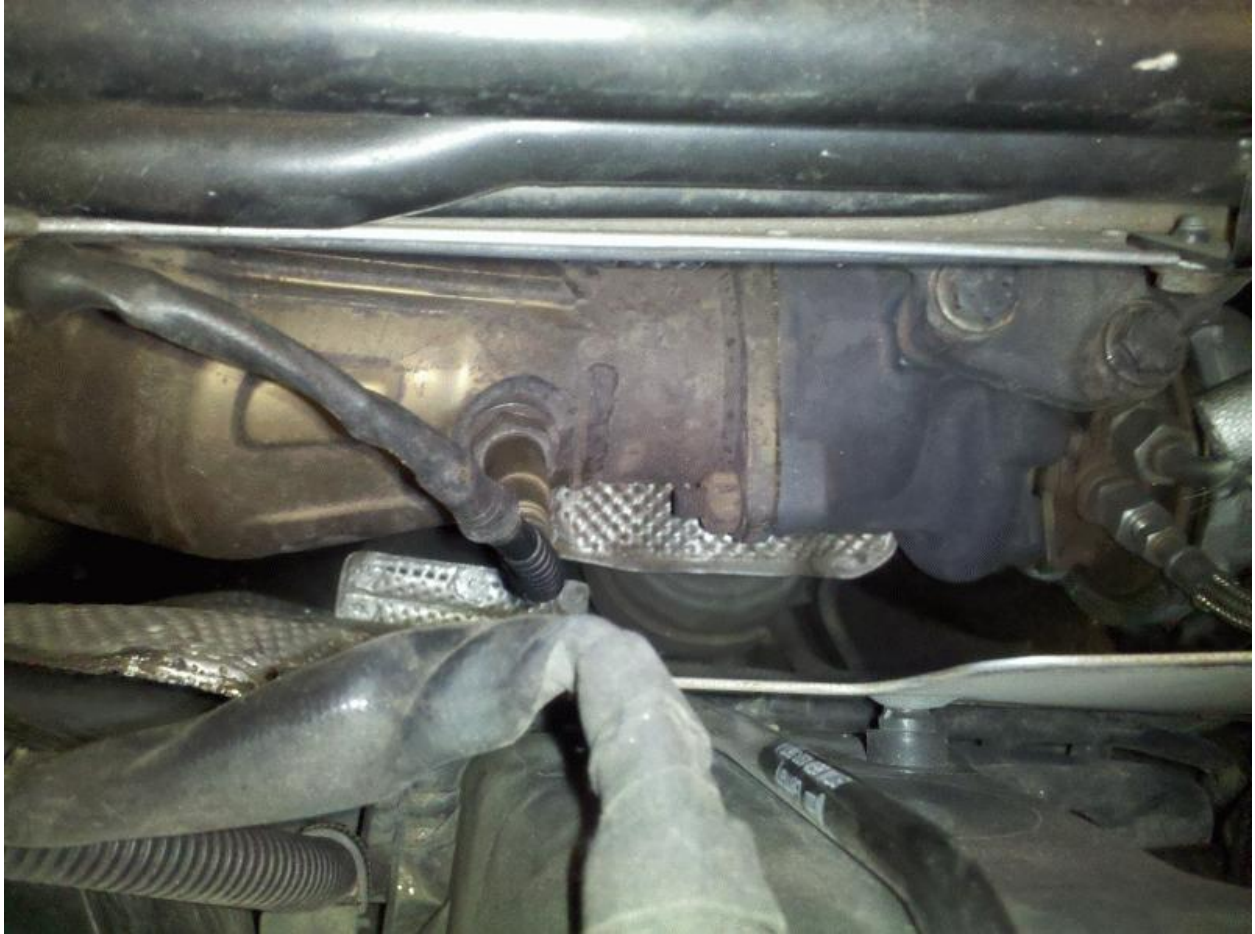
## Audi exhaust

The catalyst is mounted directly after the turbocharger on the Audi.

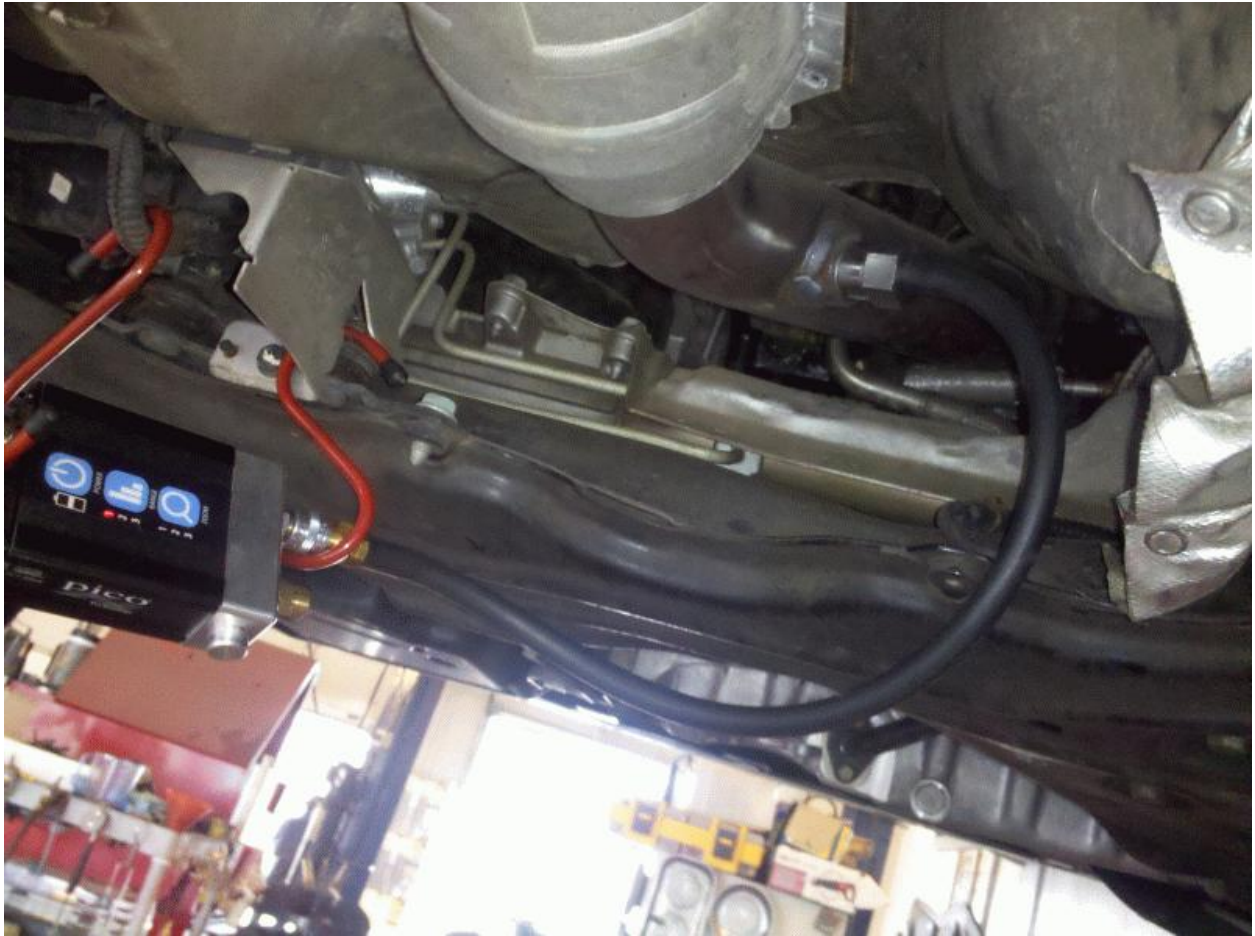
## Beetle exhaust

The catalyst on the Beetle is mounted further down than the Audi. This image also displays the pressure transducer used during testing and the test connections.

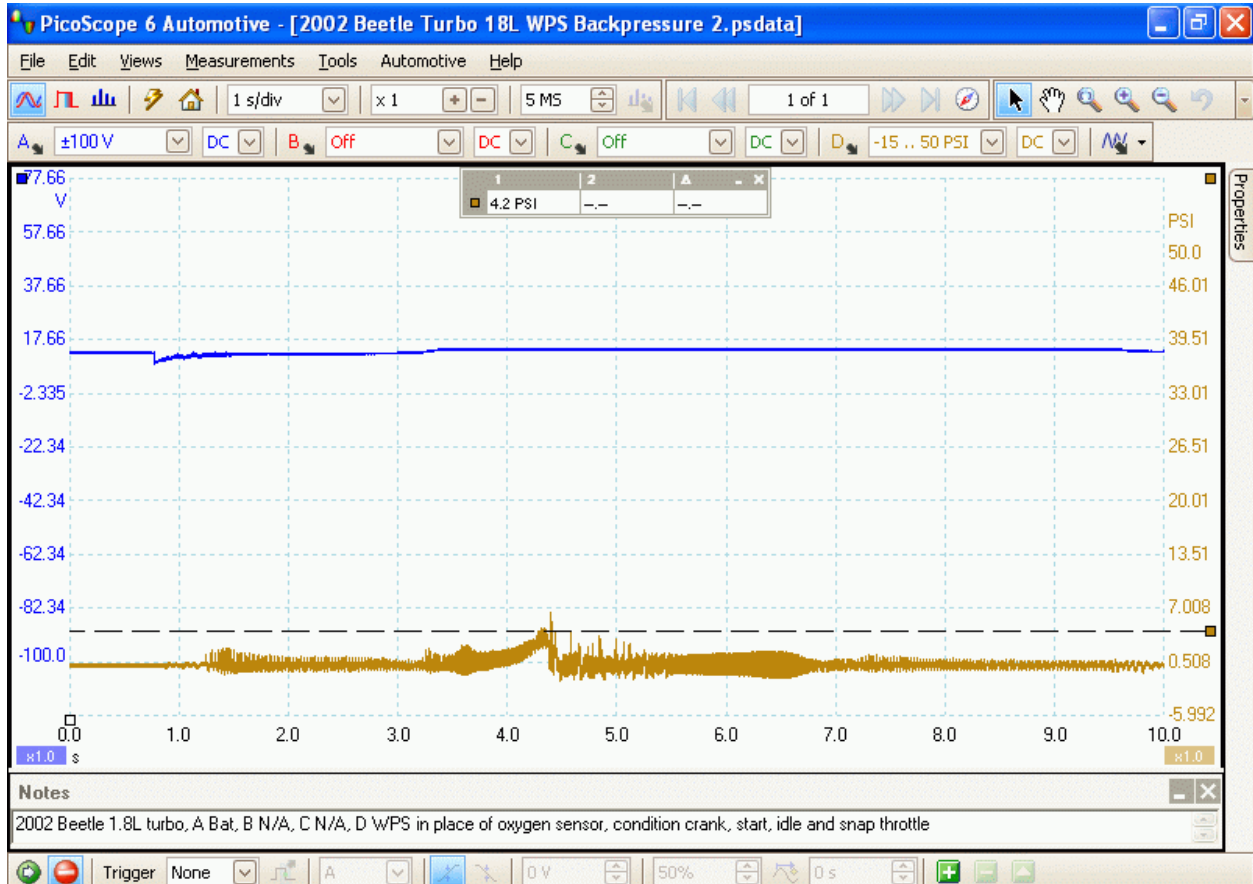
## Beetle back pressure results

In this waveform only the exhaust back pressure and the battery voltage was recorded. The test conditions were the same crank, start idle and then a snap throttle. The peak exhaust back pressure was only 4.2PSI. The original test on the Audi the peak pressure was between 14 and 18PSI. At this point it was good idea to take a look at the front of the catalytic converter on the A4.

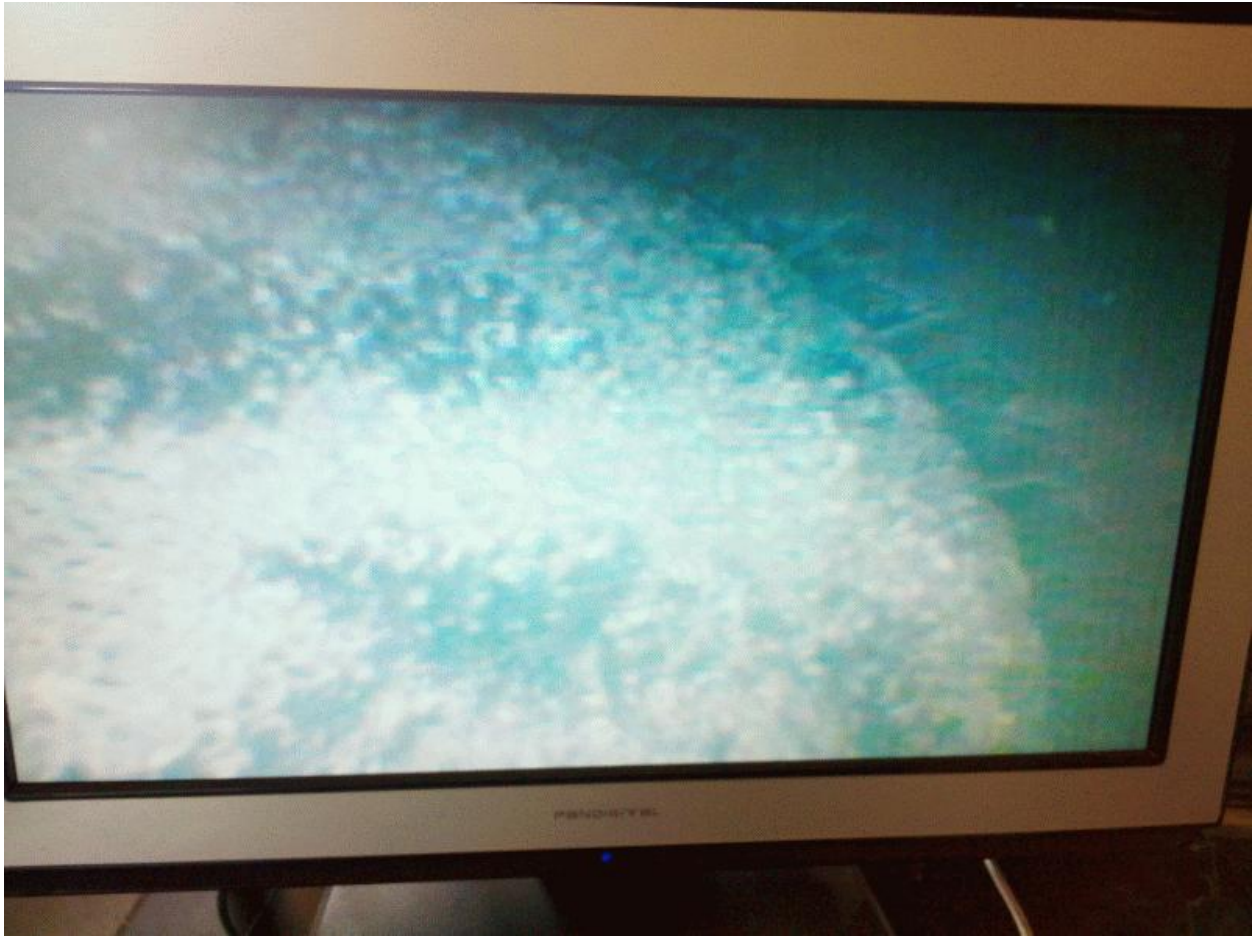
## Cat inspection

This image is of the inside of the catalytic converter using a video inspection device connected to a monitor. The image is not perfectly clear on the monitor but does indicate a problem is present with the cat. A good cat will have a honeycomb shaped substrate. This cat appears to be damaged. A damaged cat can increase the backpressure present resulting in poor performance.

Also, worth noting is the damage present on the cat is typical of misfires being present. There were codes for misfires present among the 18 codes present. At the time of testing the vehicle was not misfiring even though engine performance was poor. The spark plugs were inspected and there were signs of one ignition coil being replaced.

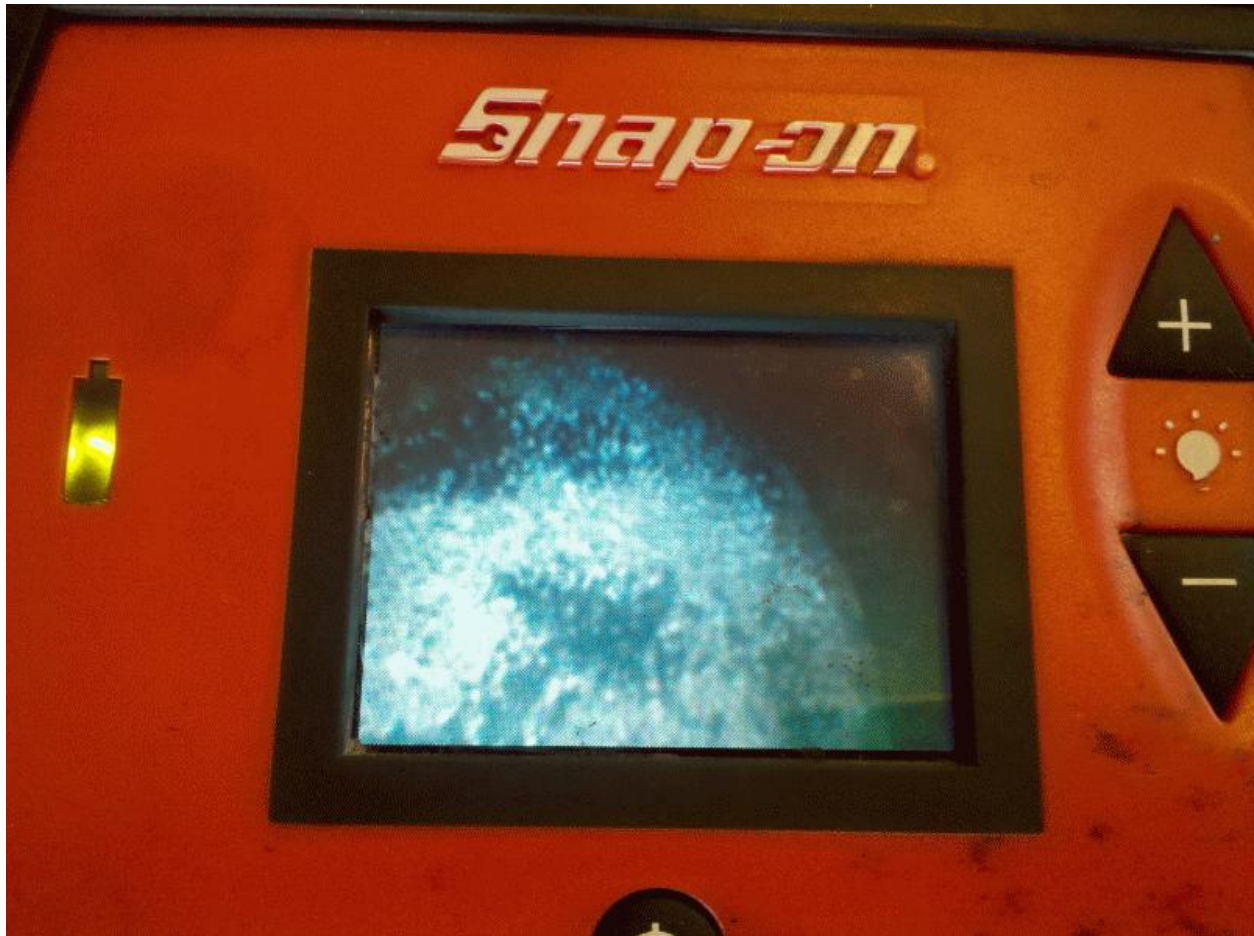
Cat inspection another view

Viewing the cat directly from the video inspection device is little more defined but the screen is much smaller. The catalyst was observed by removing the exhaust sensor and using the 90 degree camera.

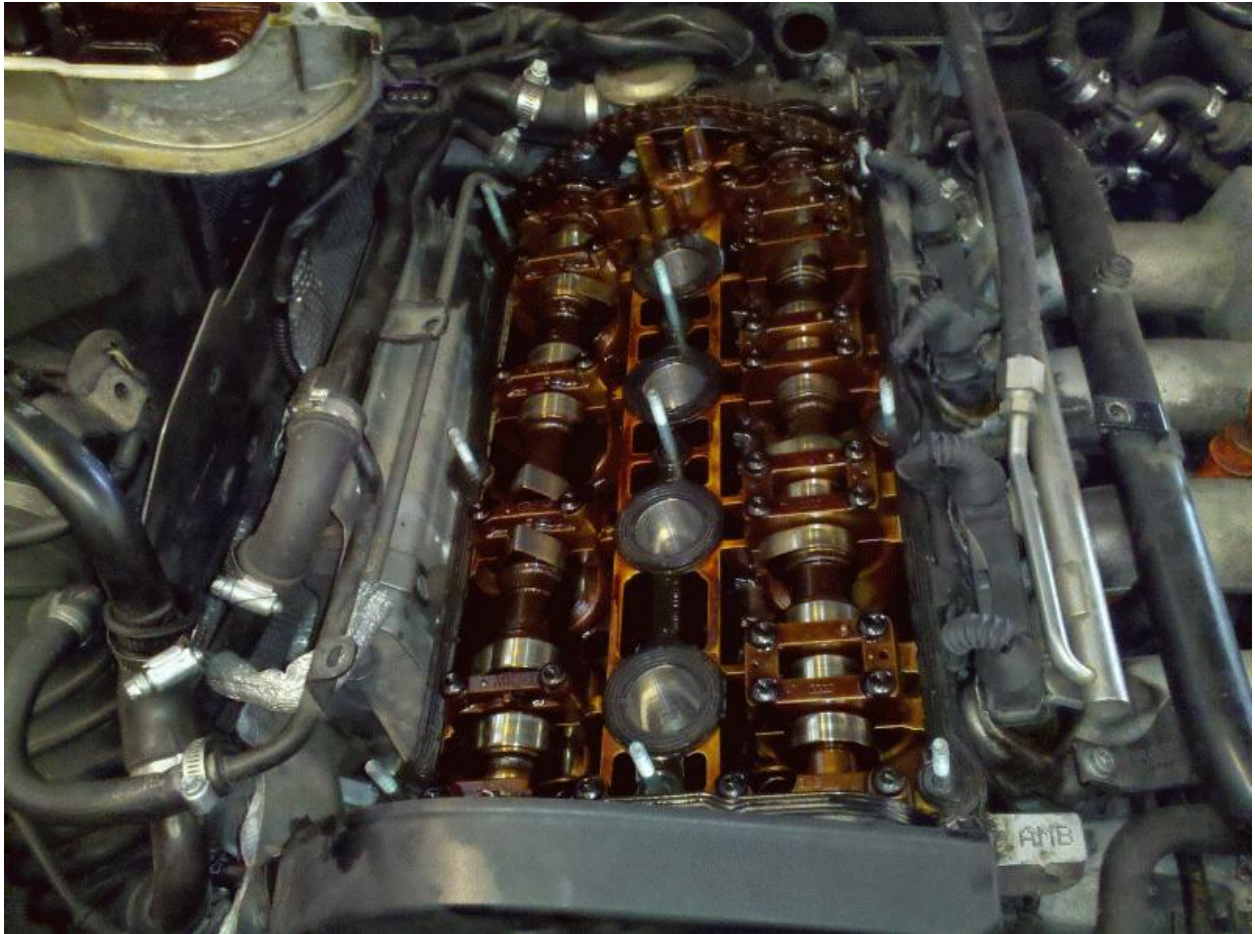
## Top end inspection

The engine top end did not show signs of sludge building up. Since the top end was not full of sludge, an estimate was presented for the catalytic converter, and the exhaust sensors.

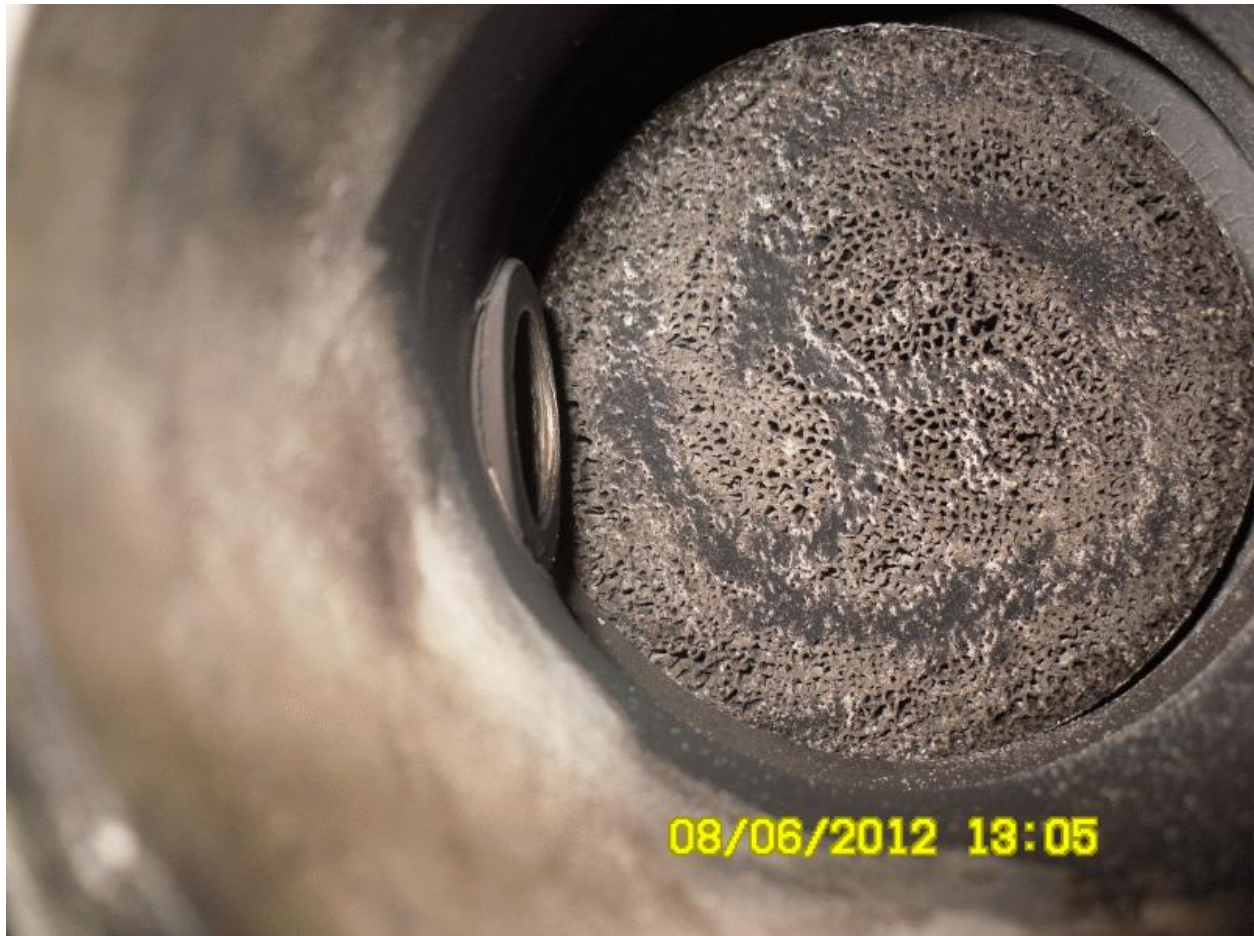
## Cat inspection out of vehicle

With the cat out of the vehicle, the damage is easier to see. The image is of the front side of the cat. The back side of the cat had a typical honeycomb shaped substrate.

With the new cat and sensors installed, the in cylinder pressure test, the back pressure test, and vacuum gauge test were repeated. The back pressure was greatly reduced. The peak pressure was now 2.8 to 3.9PSI, and the engine did seem to run better. The in cylinder pressure test, still indicated low vacuum. This was also verified by the vacuum gauge.

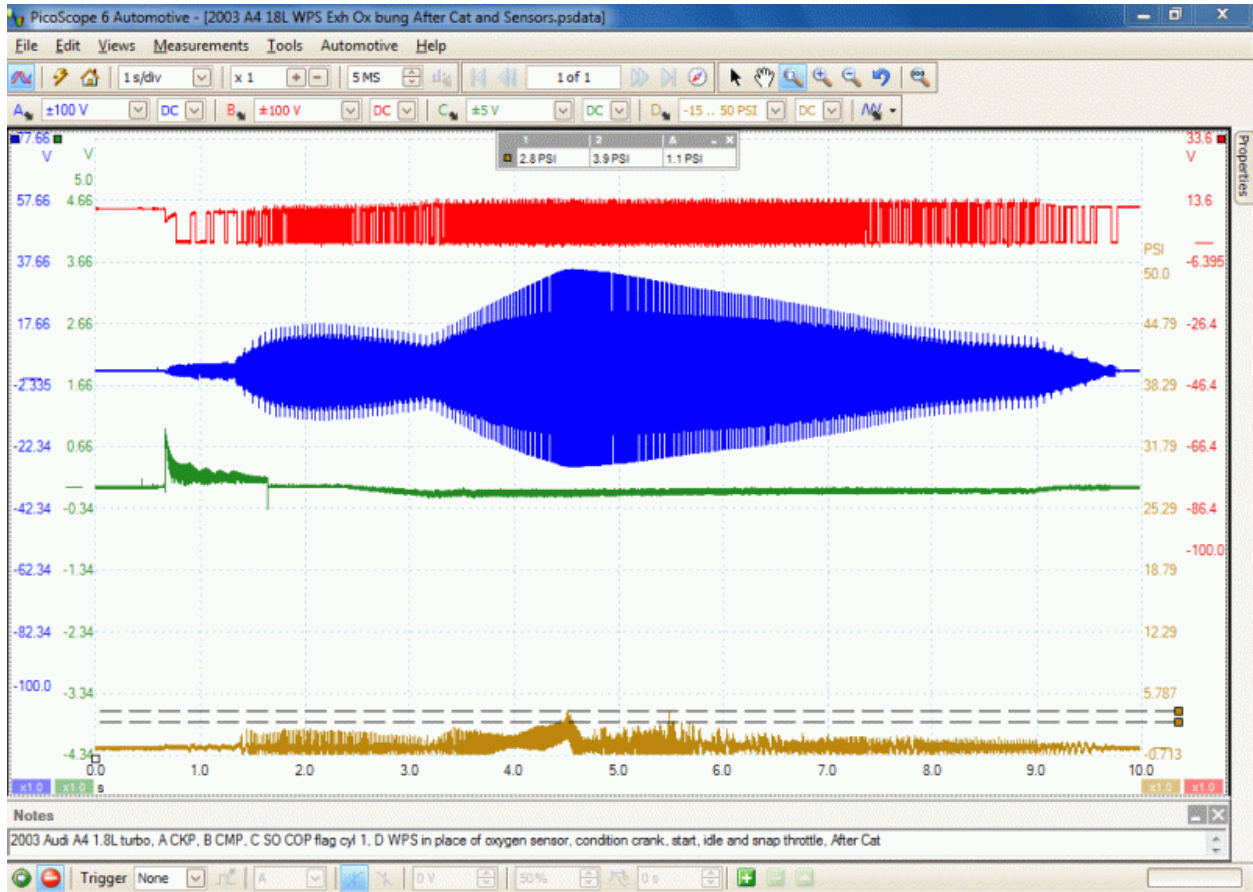
## Back pressure after cat replacement

Peak back pressure is now 2.8 to 3.9PSI. Back pressure prior to cat replacement was 14 to 18PSI.

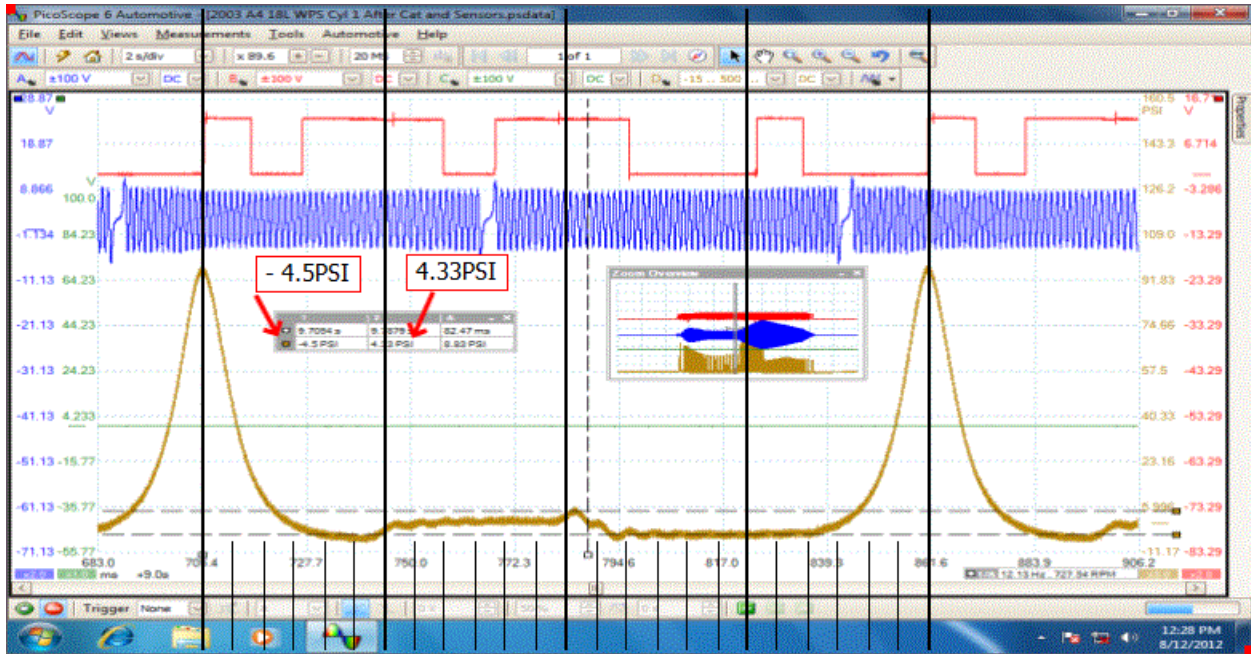
### In cylinder pressure after cat replacement

While the back pressure was reduced, not a whole lot changed in the pressure waveform. The vacuum increased a small amount, but the pressure peak is still present prior to the intake stroke. The intake camshaft timing still appears questionable.

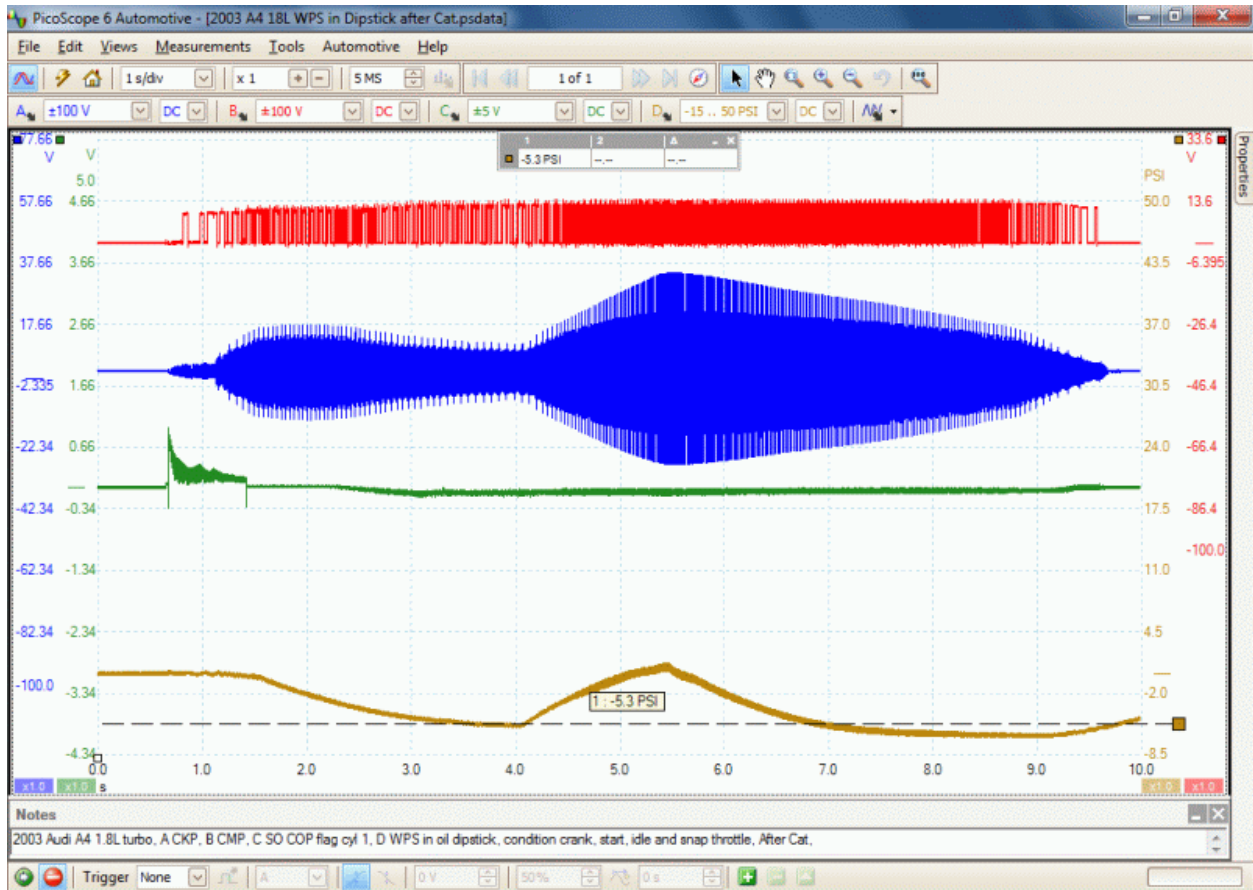
## Crank case pressure

Previously the engine vacuum was 8"HG it was now 10"HG which is still low. Again an attempt to perform basic settings was attempted. The fuel trim correction was still at +25 and the code P1711/17519 returned. Further testing found 8"HG present in the crankcase indicating too much vacuum present in the crankcase. The crankcase ventilation system has several components on this vehicle and appears a little complicated. The VW parts department indicated usually they serviced the breather system by replacing most of the components.

Test conditions crank, start, idle and snap throttle. Test point is at oil dipstick tube using WPS confirming vacuum gauge reading.

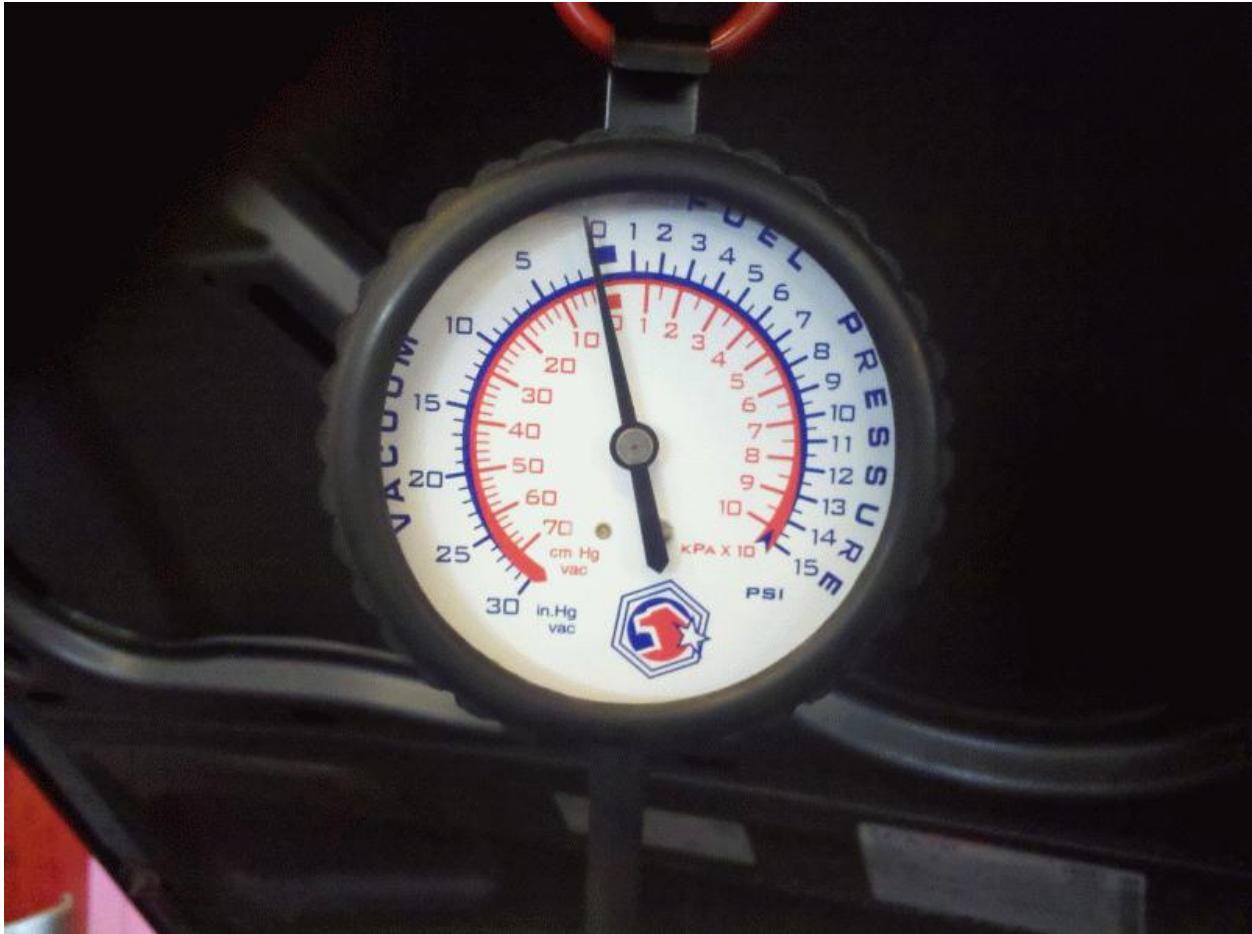
Crank case pressure vacuum gauge

An image of a vacuum gauge tied into the crank case via the oil dipstick. Prior to the breather system repair 8"HG of vacuum was present. After the repair less than 1"HG was present.

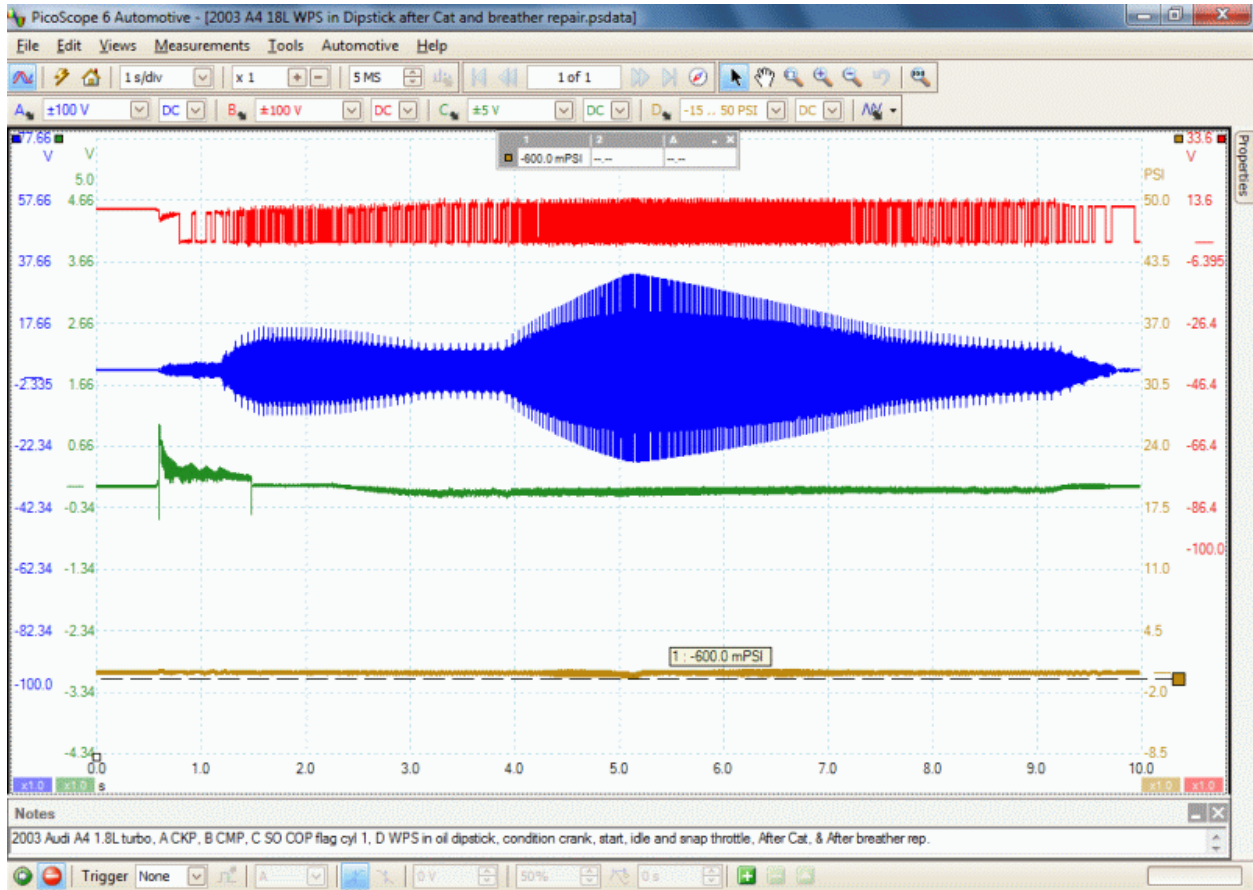
## Crank case pressure WPS

Crank case pressure after breather repair. There was an 8"HG vacuum present in crank case prior to repair.

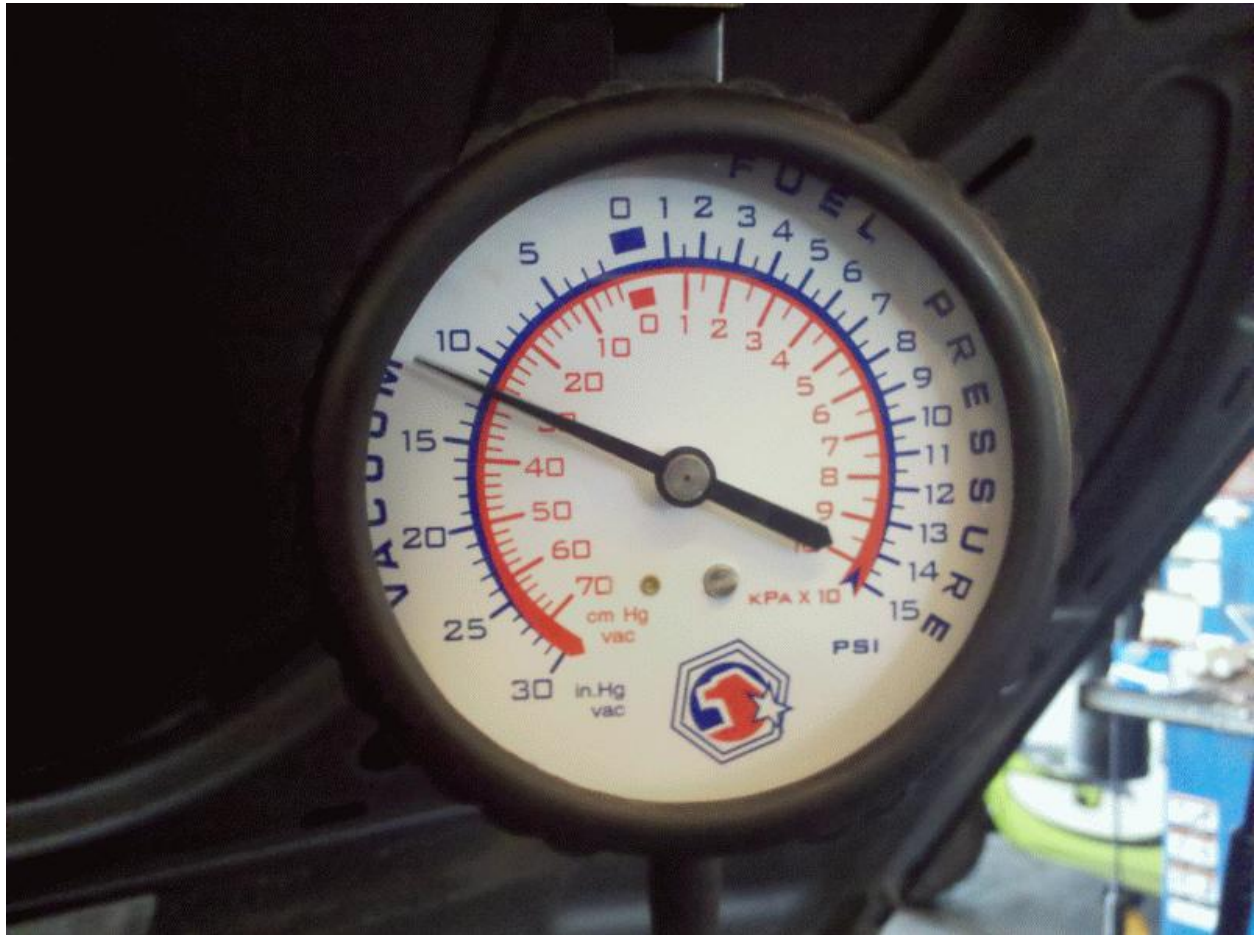
## Engine vacuum

Engine vacuum after repairing the crank case ventilation system, the original vacuum was 8"HG. After replacing the catalyst the vacuum increased to 10"HG. In this image the vacuum increased to 12"HG but is still low.

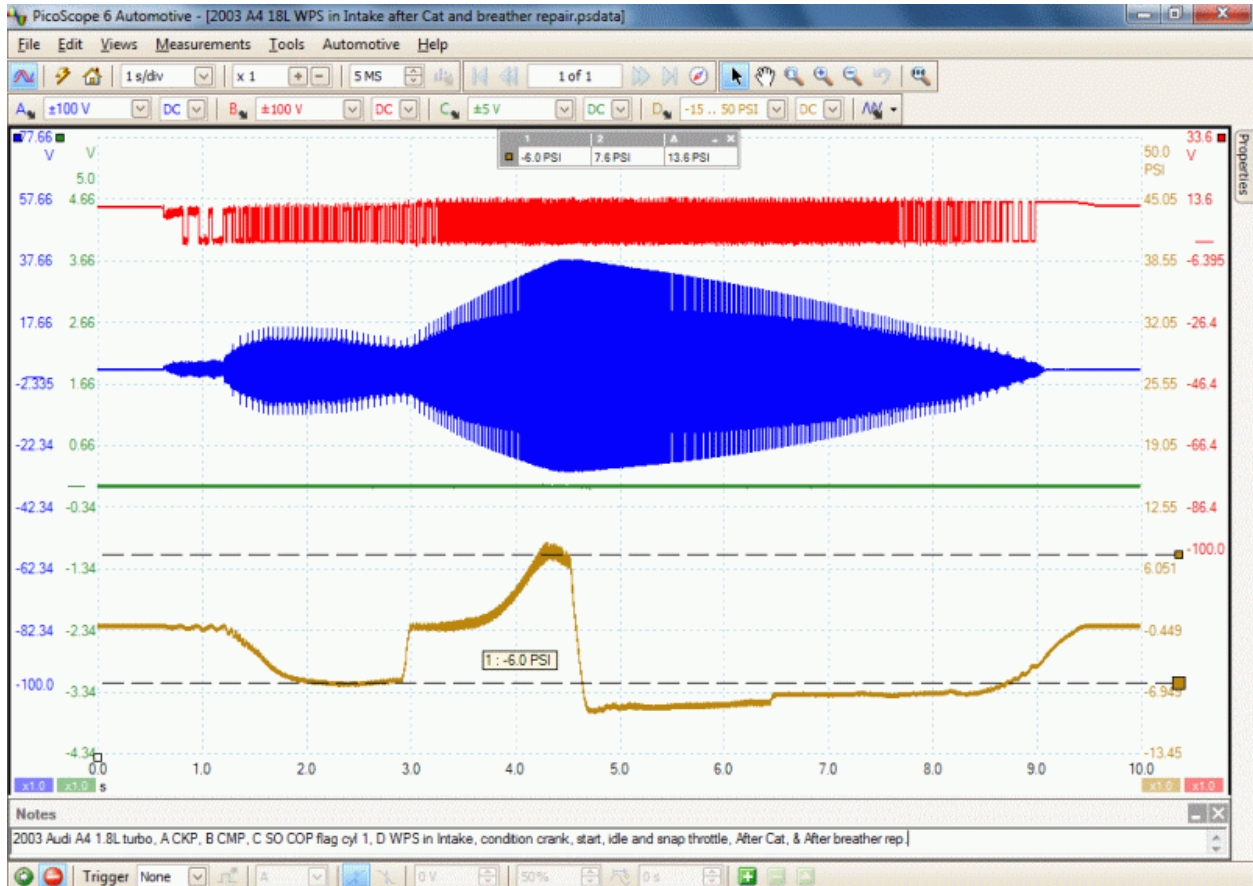
## Engine vacuum WPS

Engine vacuum improved but did not reach the normal range of 15 to 17"HG. The WPS readings are in PSI. A rough conversion from PSI to "HG is to multiply by 2.04. In this image, the vacuum is near identical to what was recorded on the traditional gauge. A snap throttle also created a boost condition from the turbo.

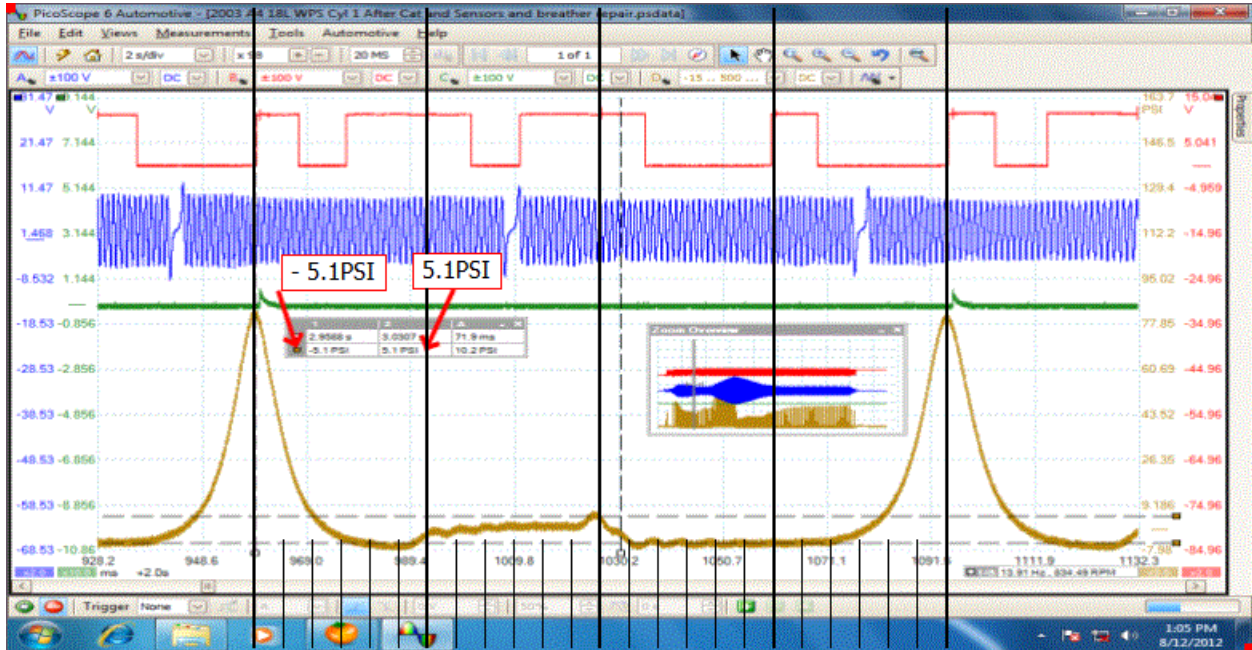
In cylinder pressure

The in cylinder pressure now has a much more defined transition to the intake stroke. Again based on where the markers are cam timing is suspect on the intake side.
